# Lymington Harbour Commissioners

## Lymington Saltmarsh Recharge by Bottom Placement: 2021 Monitoring Report

Updated bathymetric survey review produced in fulfilment of  
Condition 5.2.11 of Marine Licence L/2014/00396/2

May 2021

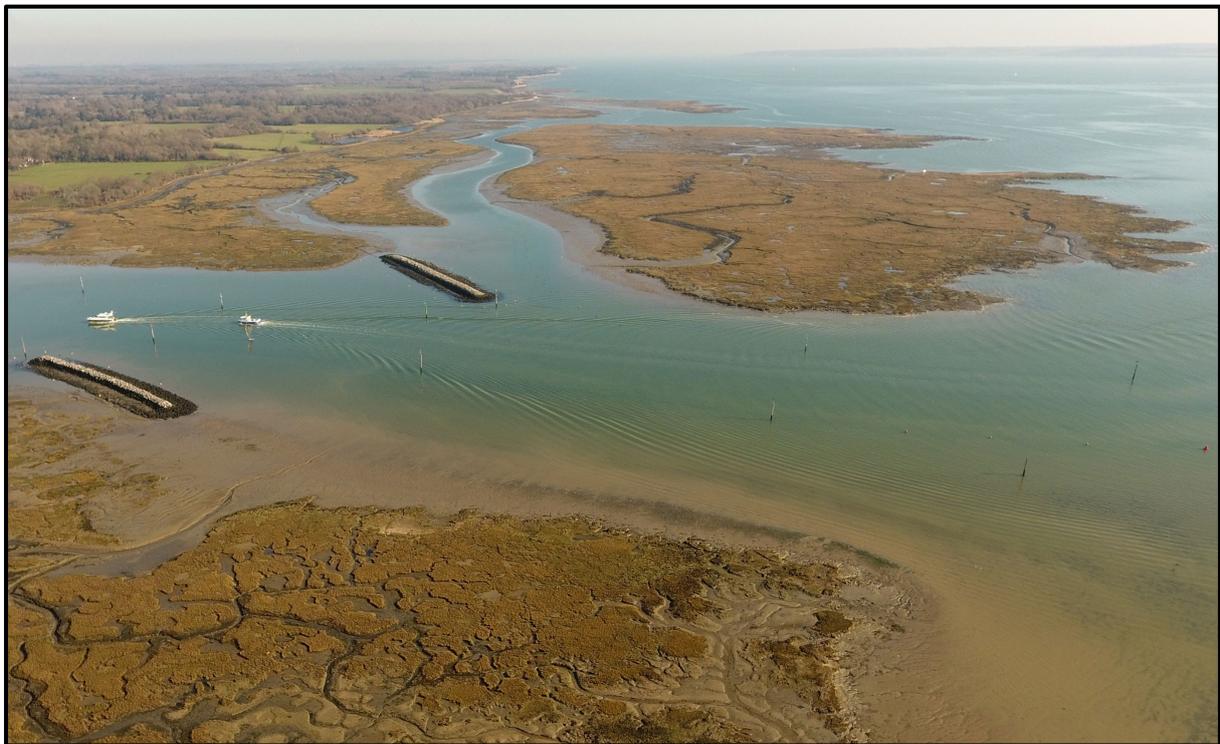
**Image 1. View of Boiler Marsh in front of Lymington harbour**

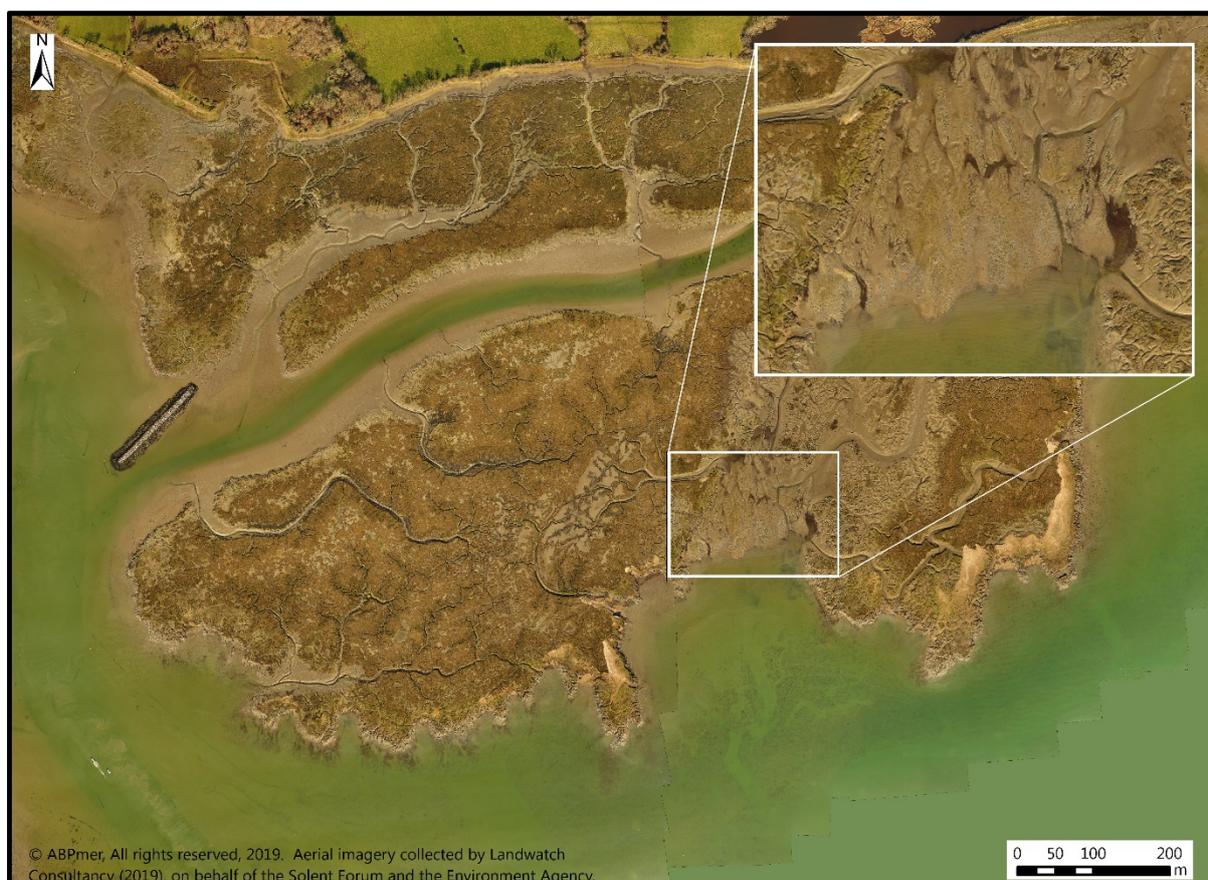
**Image 2. Close up view of the beneficial deposit ground in front of Boiler Marsh**

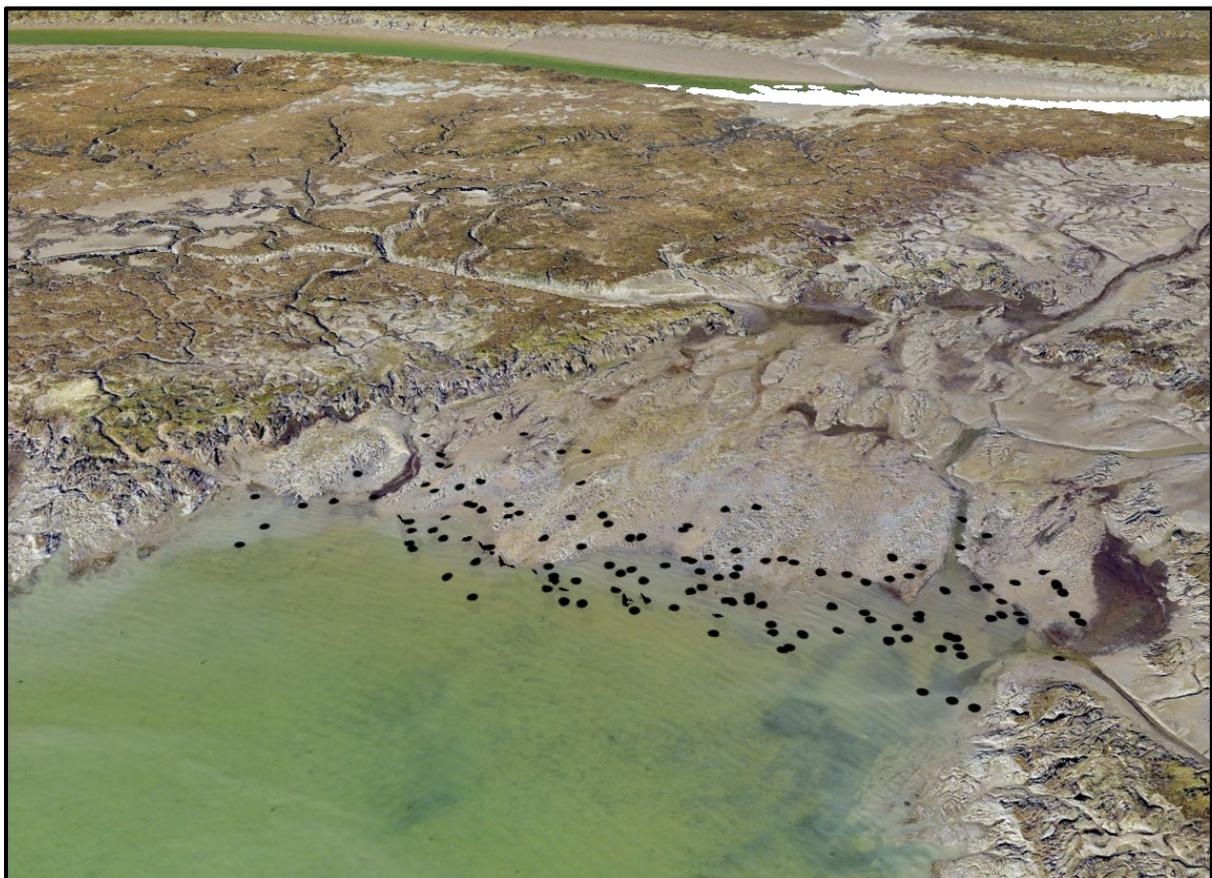
ABPmer image using Landwatch aerial photo from February 2019 laid over 2020 Lidar and 2021 bathymetry data

**Image 3. Placement site showing deposit locations during 2019/20 and 2020/21 campaigns**

It is apparent from Figure 9 and Figure 10, as well as the disposal points in Figure 2, that hopper barges are having to deposit progressively further seaward of previous placements as the inshore areas become less accessible/higher. Also, the sediment is increasingly being placed across the full width of the disposal area and into the eastern side, whereas in the first campaign, the placements were mainly in the western section (see Figure 6). This is further illustrated in Image 3, which shows the location of the 2019/20 and 2020/21 deposit sites laid over a 3D image of the deposit ground.

<sup>4</sup> In the 2019/20 winter, around 7,600 m<sup>3</sup> sediment was deposited (see Table 1) in 80 discrete locations. In 2020/21 it was 6,270 m<sup>3</sup> in 66 locations

This change in the deposition locations is itself encouraging. It further reflects the fact that large proportions of the previous deposits are remaining in place and reducing the water depths in the areas closest to the marsh edge.
